# **Navajo Abandoned Uranium Mine**

## **Site Screen Report**

### **Pope 1 AUM Site**

**August 2010**

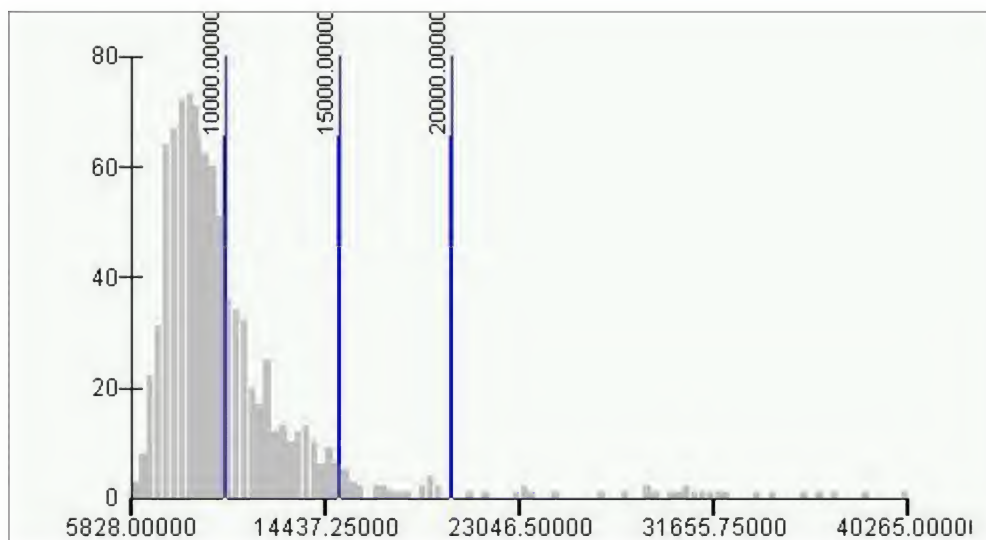
The following chart and statistics were generated by ESRI ArcGIS 9.3.1, and show the general distribution of the site gamma *radiation* measurements. The horizontal X axis represents the gamma radiation reading levels in cpm (lowest levels to the left). The vertical Y axis represents the frequency of each gamma radiation level.

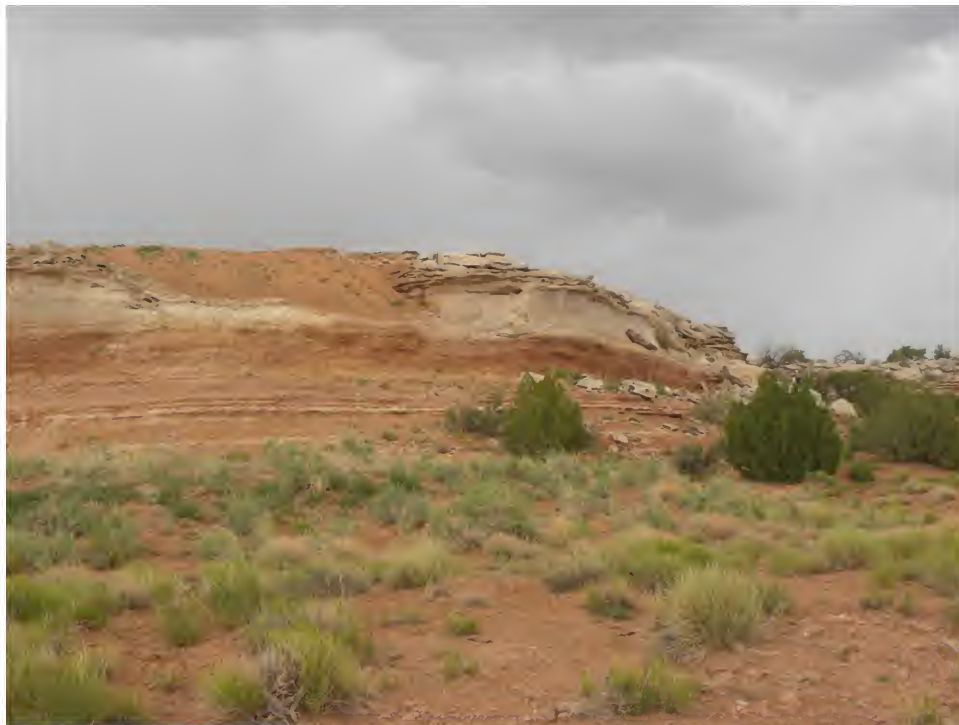
Photo 1. Pope 1 site

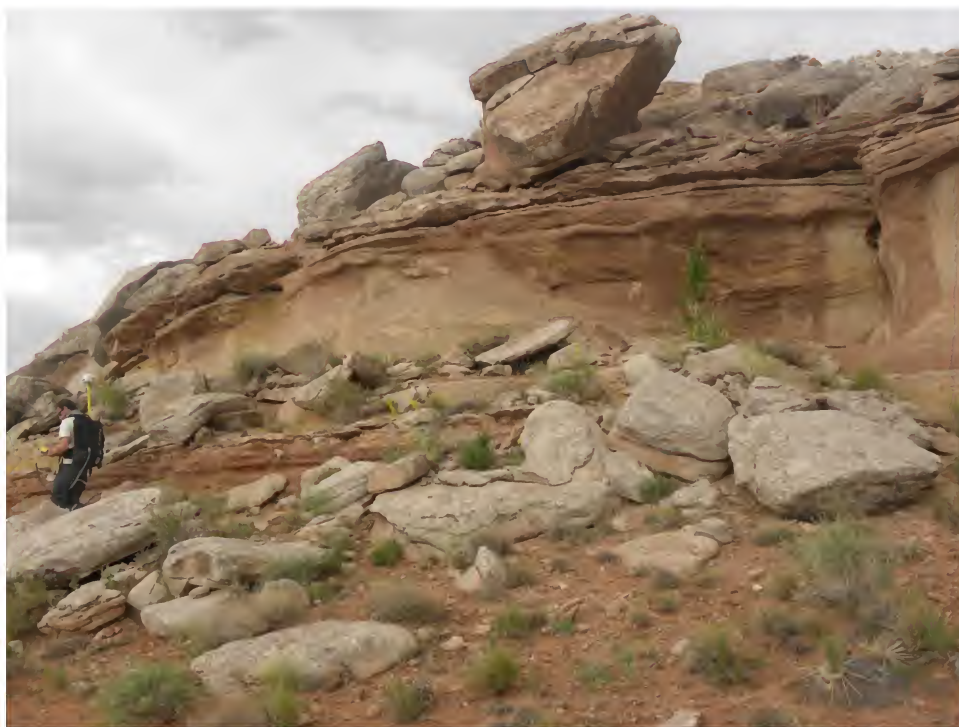
Photo 2. Pope 1 site

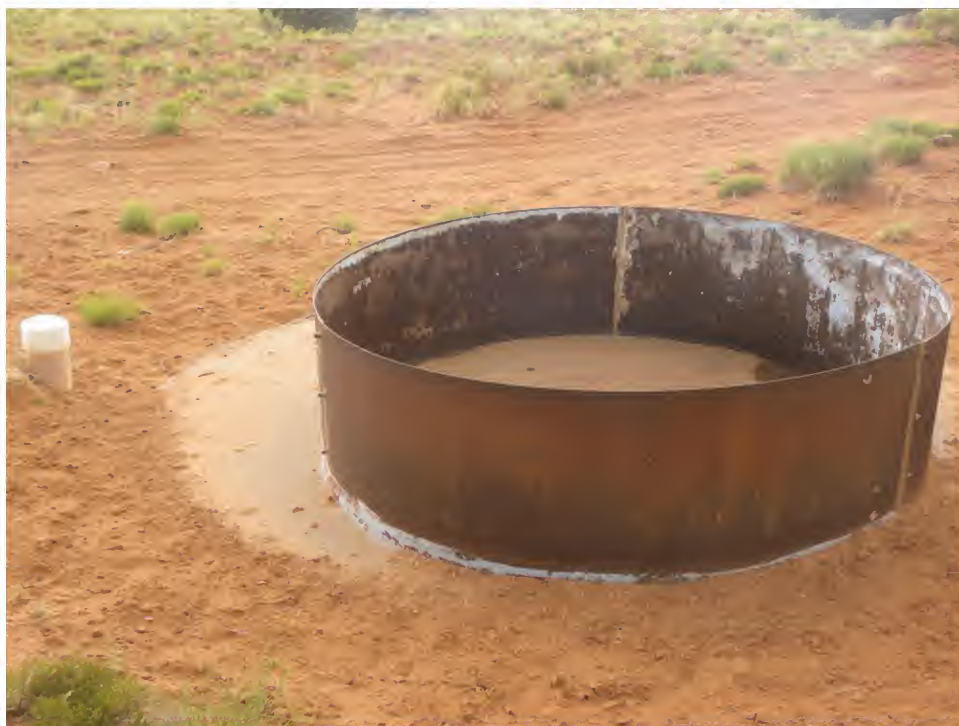
**0 to 0.25 miles:** Well at Clark house, 0.1 mi N of site, water trough for grazing sheep immediately NW of site

Photo 3. Pope 1, water trough

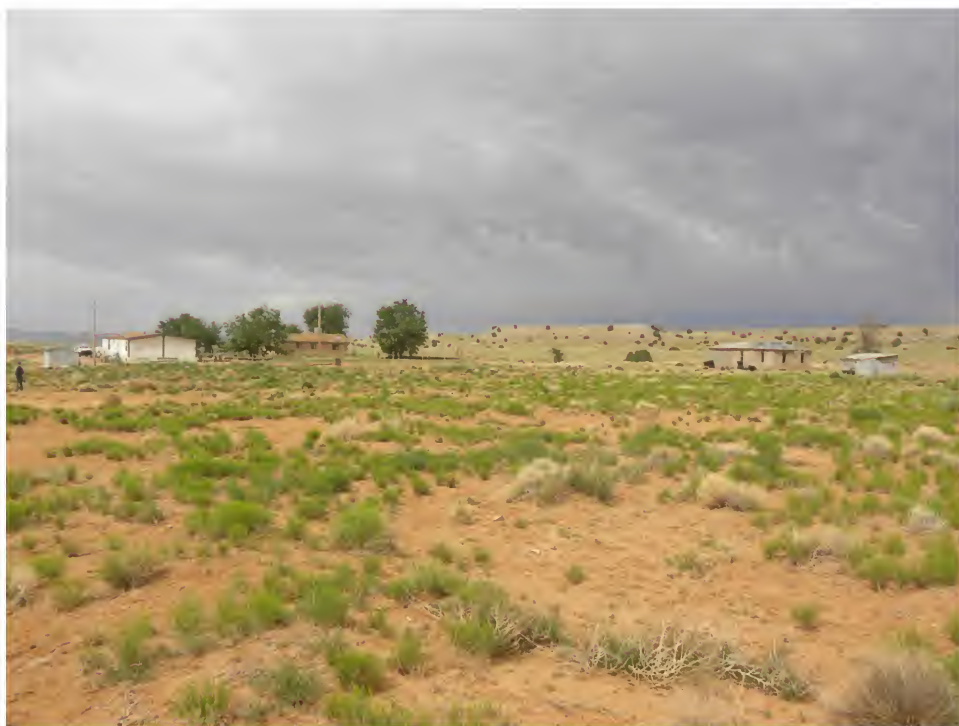
**200 feet to 0.25 mile:** Clark housing compound (3 houses, many other structures) approx 0.1 mi N of site

Photo 4. Pope 1, Clark house

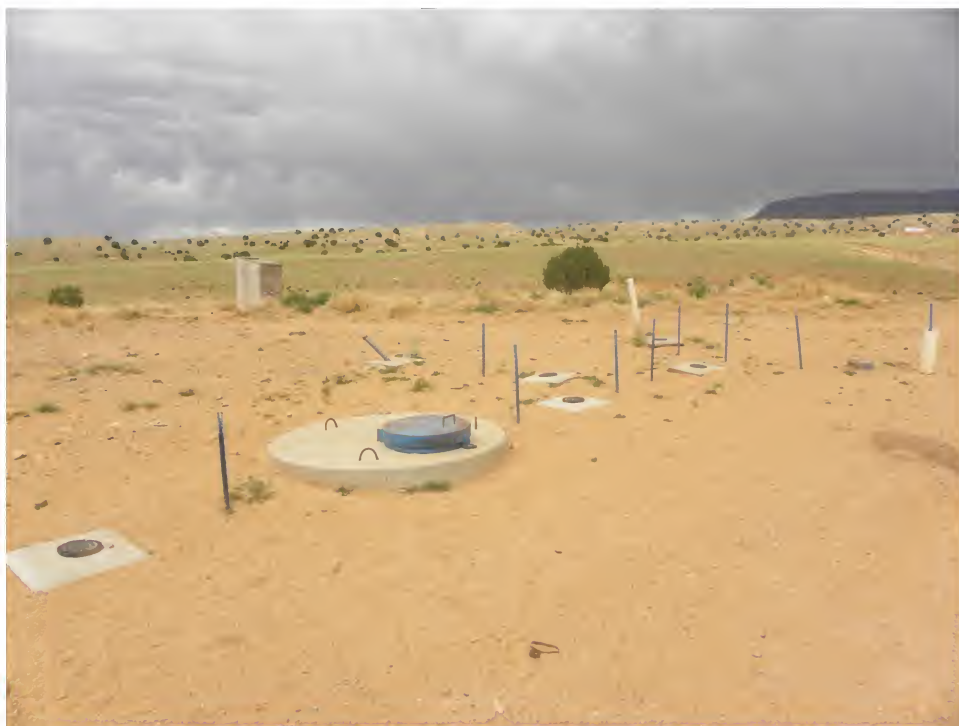
Photo 5. Pope 1, Clark house well

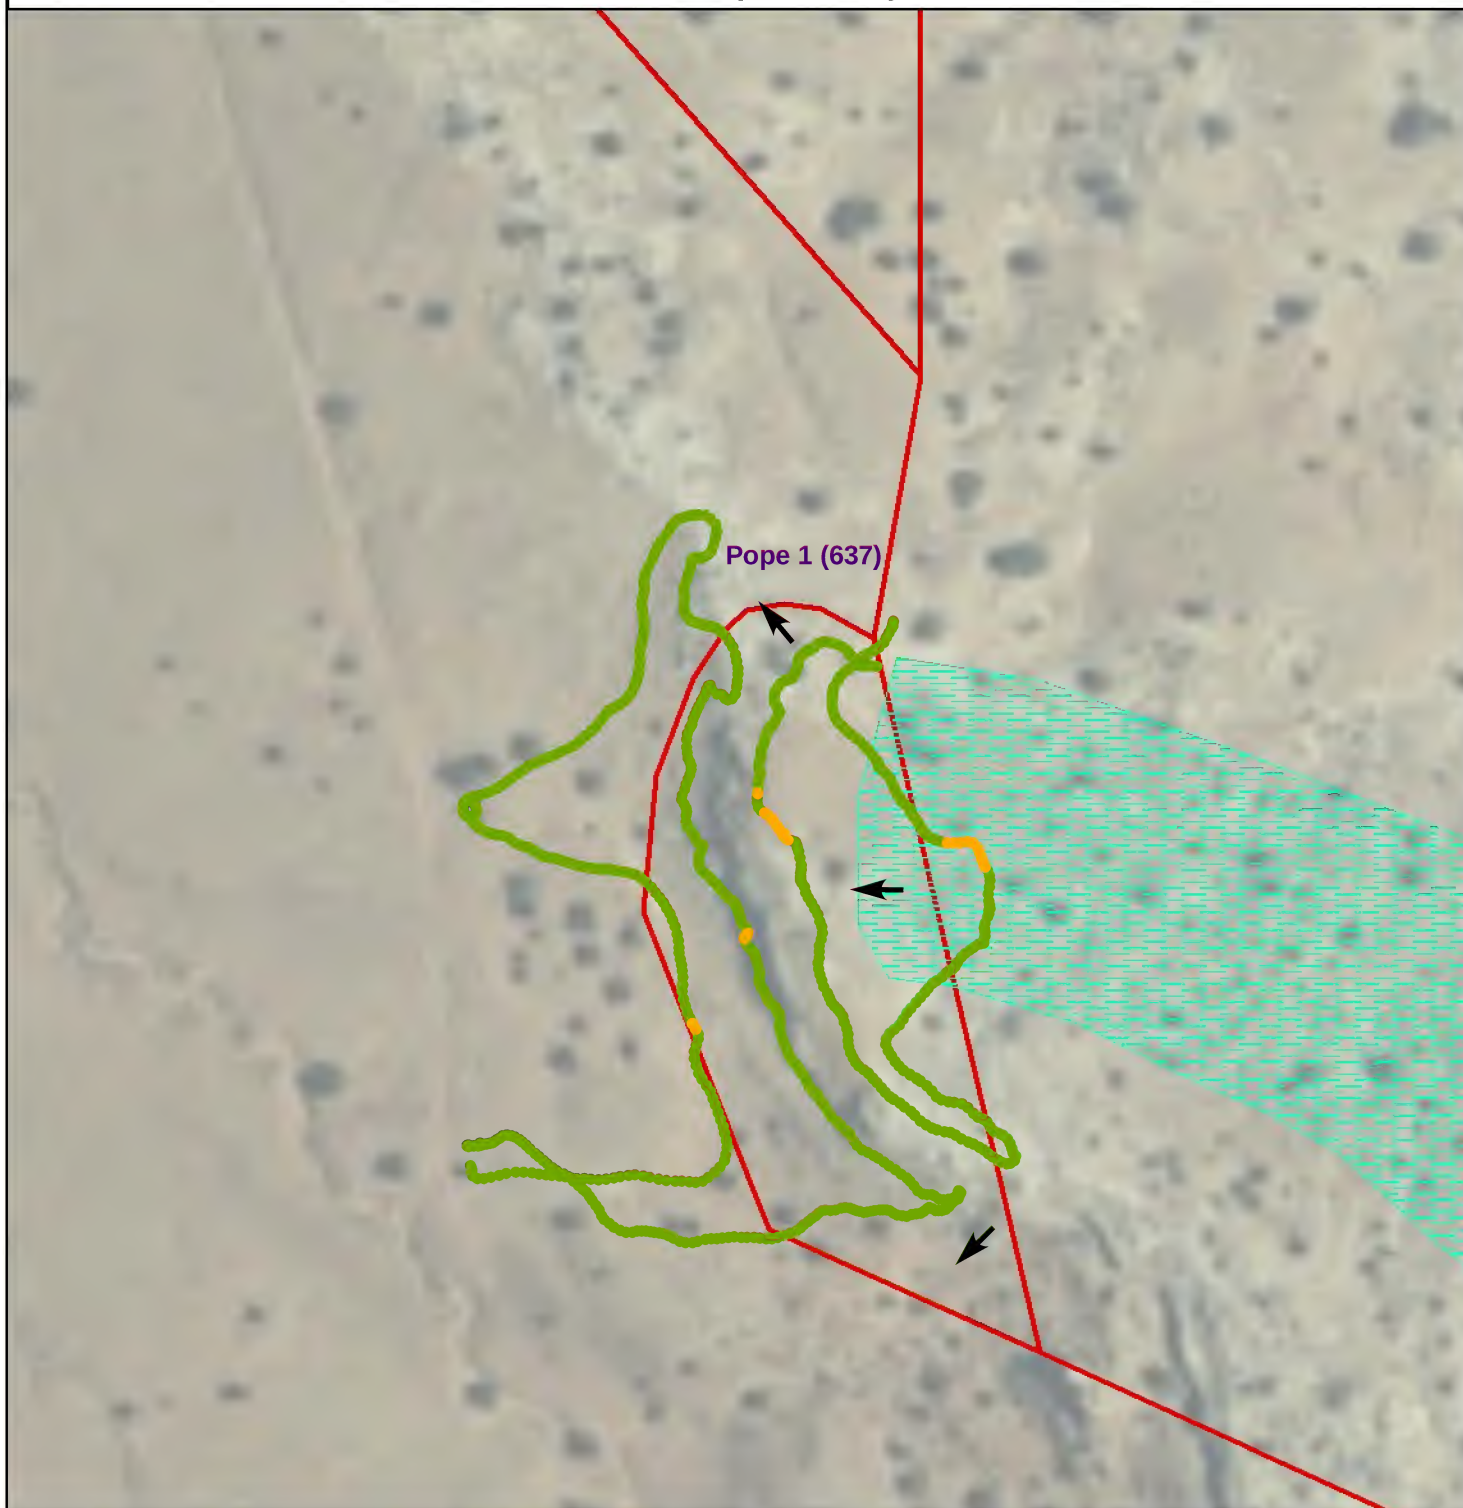
**Figure 1 - Gamma Radiation Measurements, Above Two Times Background  
Pope 1 (637)  
Teec Nos Pos Chapter, Navajo Nation**

A total of 892 gamma radiation measurements were collected from the mine site, ranging from 5,828 cpm to 40,265 cpm. The measurements are represented in Figures 1 and 2.

Gamma survey conducted 06/2010  
Measured as counts per minute (cpm)

Average background = 9,156 cpm

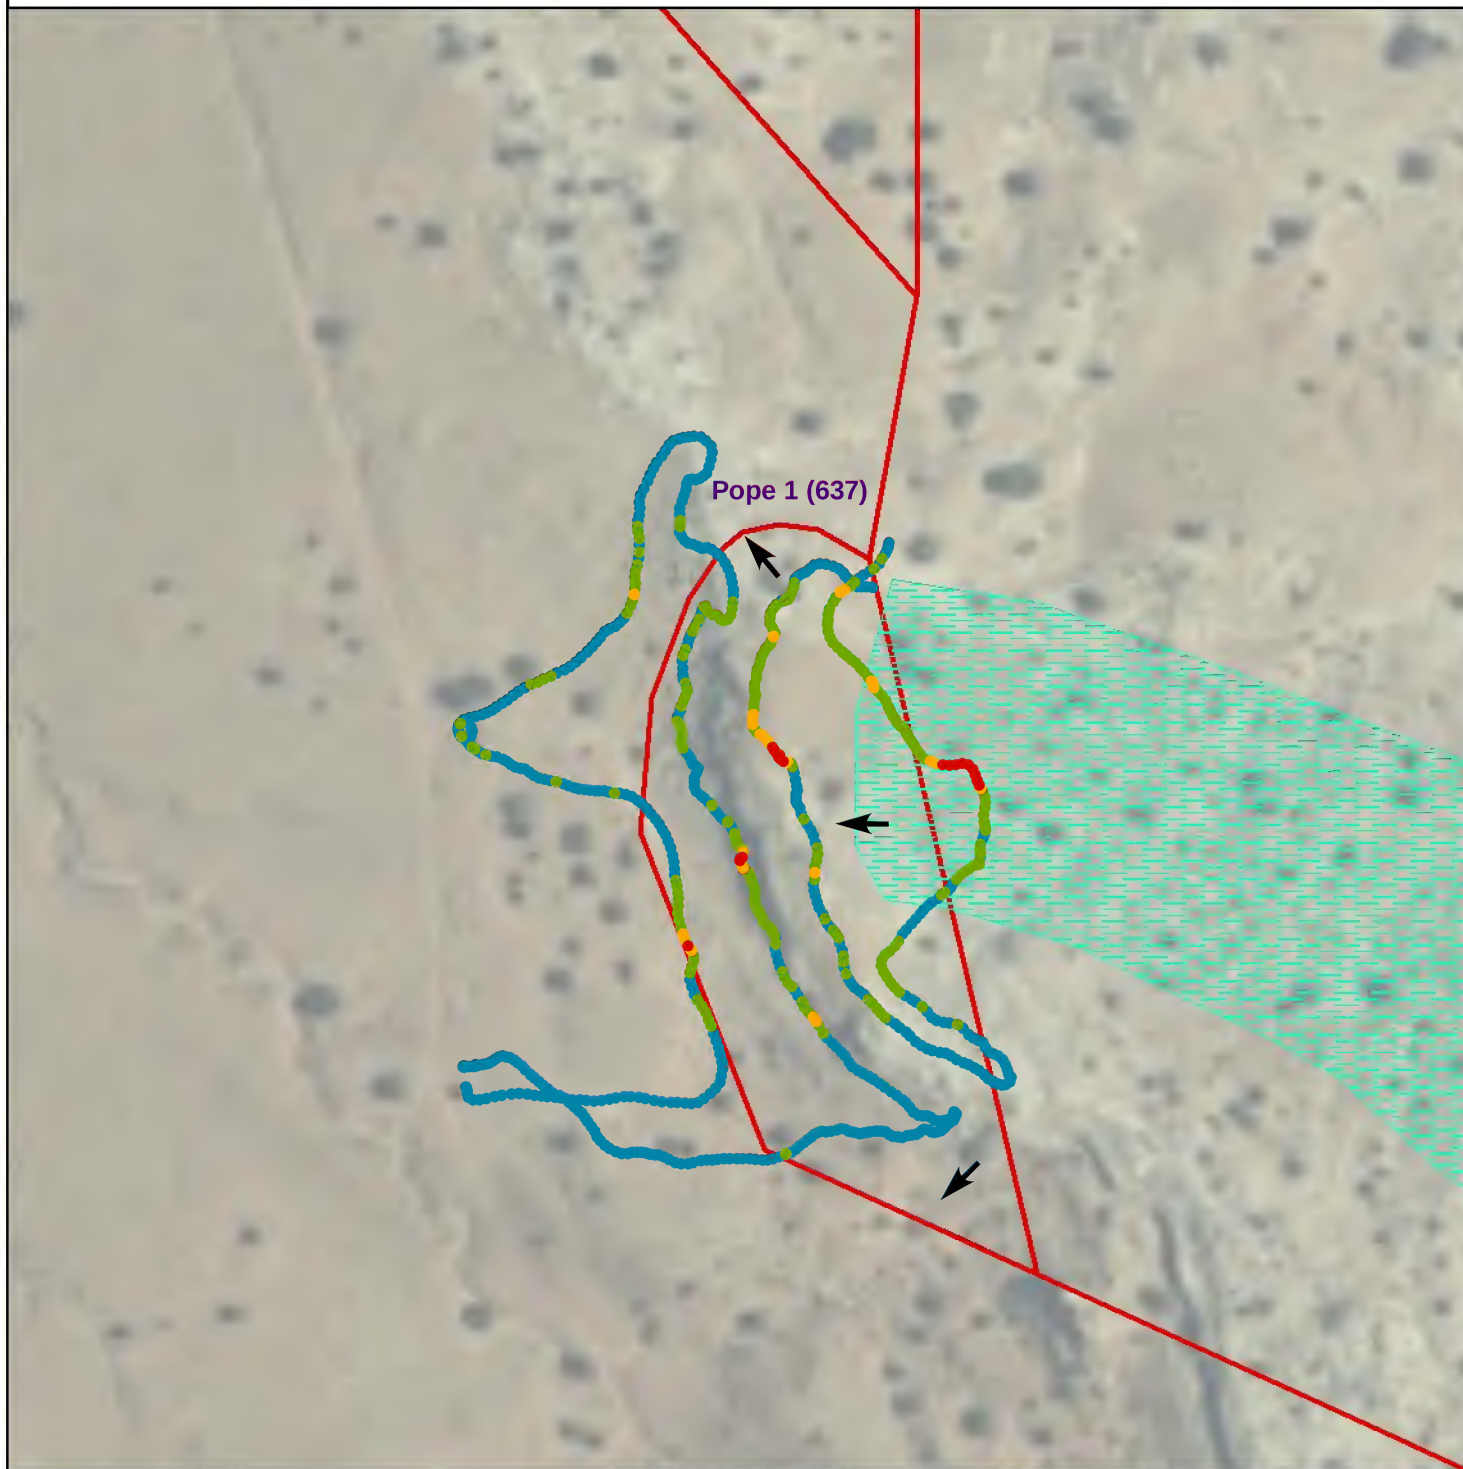
Figure 2 - Gamma Radiation Measurements  
Pope 1 (637)  
Teec Nos Pos Chapter, Navajo Nation

Gamma survey conducted 06/2010  
Measured as counts per minute (cpm)

Average background 9,156 cpm
